3 Description of diagnostic letters F... and E...

3.1 Error diagnostic messages F...

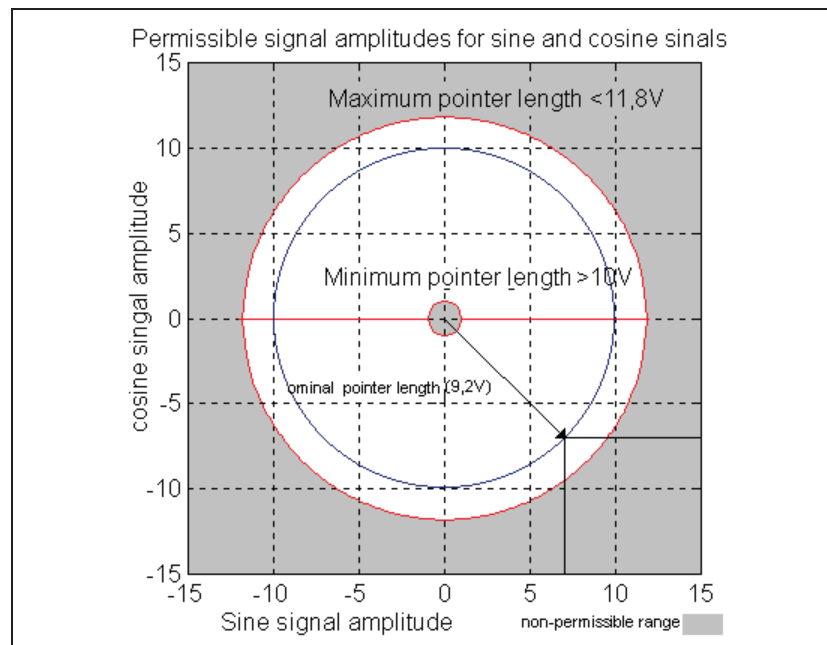
Fig. 3-8: : Correct signal amplitude

F822 Encoder 1 failure: signal too small

$$\text{Pointerlength} = \sqrt{\sin^2 + \cos^2}$$

Fig. 3-7: : Pointer length
